# Manhole Inspection Summary

Manhole # S19GG\_021MH

Insp Date: **6/13/07 9:12 AM**

**Location** Address: **1521 PULASKI ST**

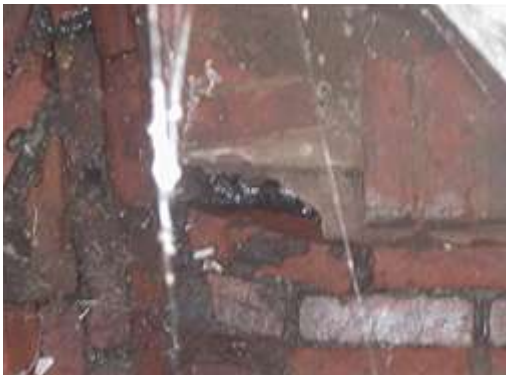
Defect 3

Condition: ☐ Sound ☐ Cracked ☐ Root Intrusion ☒ **Deteriorated** ☐ Leaks ☐ Debris

DETERIORATION OF BENCH

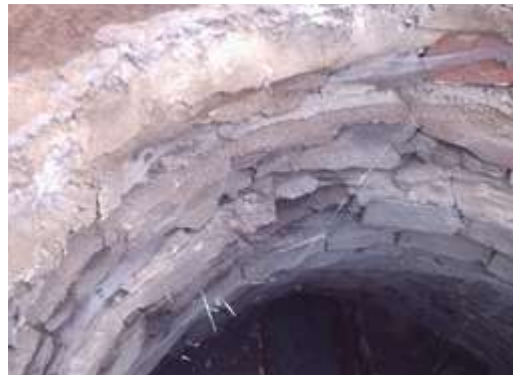
Defect 2

Condition: ☐ Sound ☐ Cracked ☐ Root Intrusion ☐ Loose Brick ☒ **Deteriorated**

DETERIORATION OF CORBEL

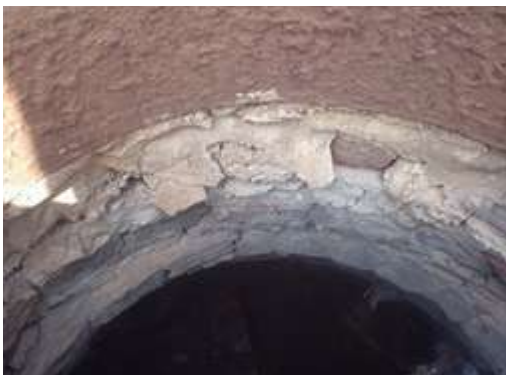
Defect 1

Condition: ☐ Sound ☐ Cracked ☐ Root Intrusion ☐ Loose Brick ☒ **Deteriorated**

DETERIORATION OF CHIMNEY

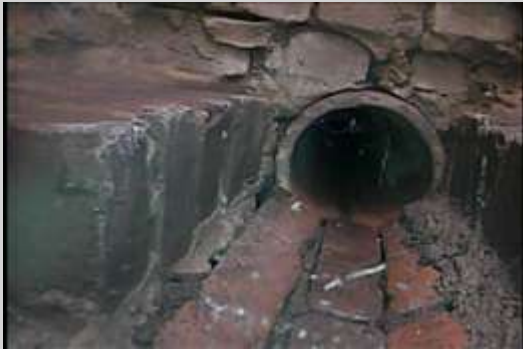
12 O'Clock Outflow

Pipe Height: **7.2** (in.) Rod and Bar (Angled)  
Pipe Material: **Clay** ☐ Pipe Lined  
Invert Depth: **5.77** (ft.) Flow Characteristics: **None**  
Deposits: ☒ None ☐ **Mud** ☐ Sludge ☐ Debris ☐ Grease  
Silt Depth: (in.) Deposits Extent:  
Infiltration: **None** Pipe Seal Cond: **Sound**

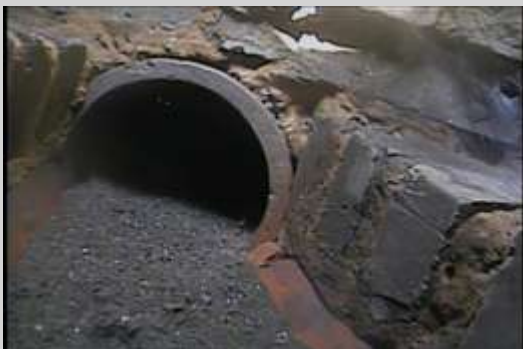
3 O'Clock Inflow

Pipe Height: **6** (in.) Rod and Bar (Angled)  
Pipe Material: **Clay** ☐ Pipe Lined  
Invert Depth: **5.24** (ft.) Flow Characteristics: **None**  
Deposits: ☒ None ☐ **Mud** ☐ Sludge ☐ Debris ☐ Grease  
Silt Depth: (in.) Deposits Extent:  
Infiltration: **None** Pipe Seal Cond: **Broken**

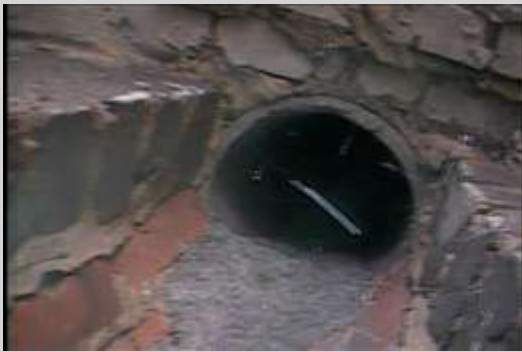
9 O'Clock Inflow

Pipe Height: **6** (in.) Rod and Bar (Angled)

Deposits: ☐ None ☒ **Mud** ☐ Sludge ☐ Debris ☐ Grease

Silt Depth: **2** (in.) Deposits Extent: **Light**
